3.0 SCRUBS

3.1 FINAL INSPECTION – WEATHER SCRUB 1

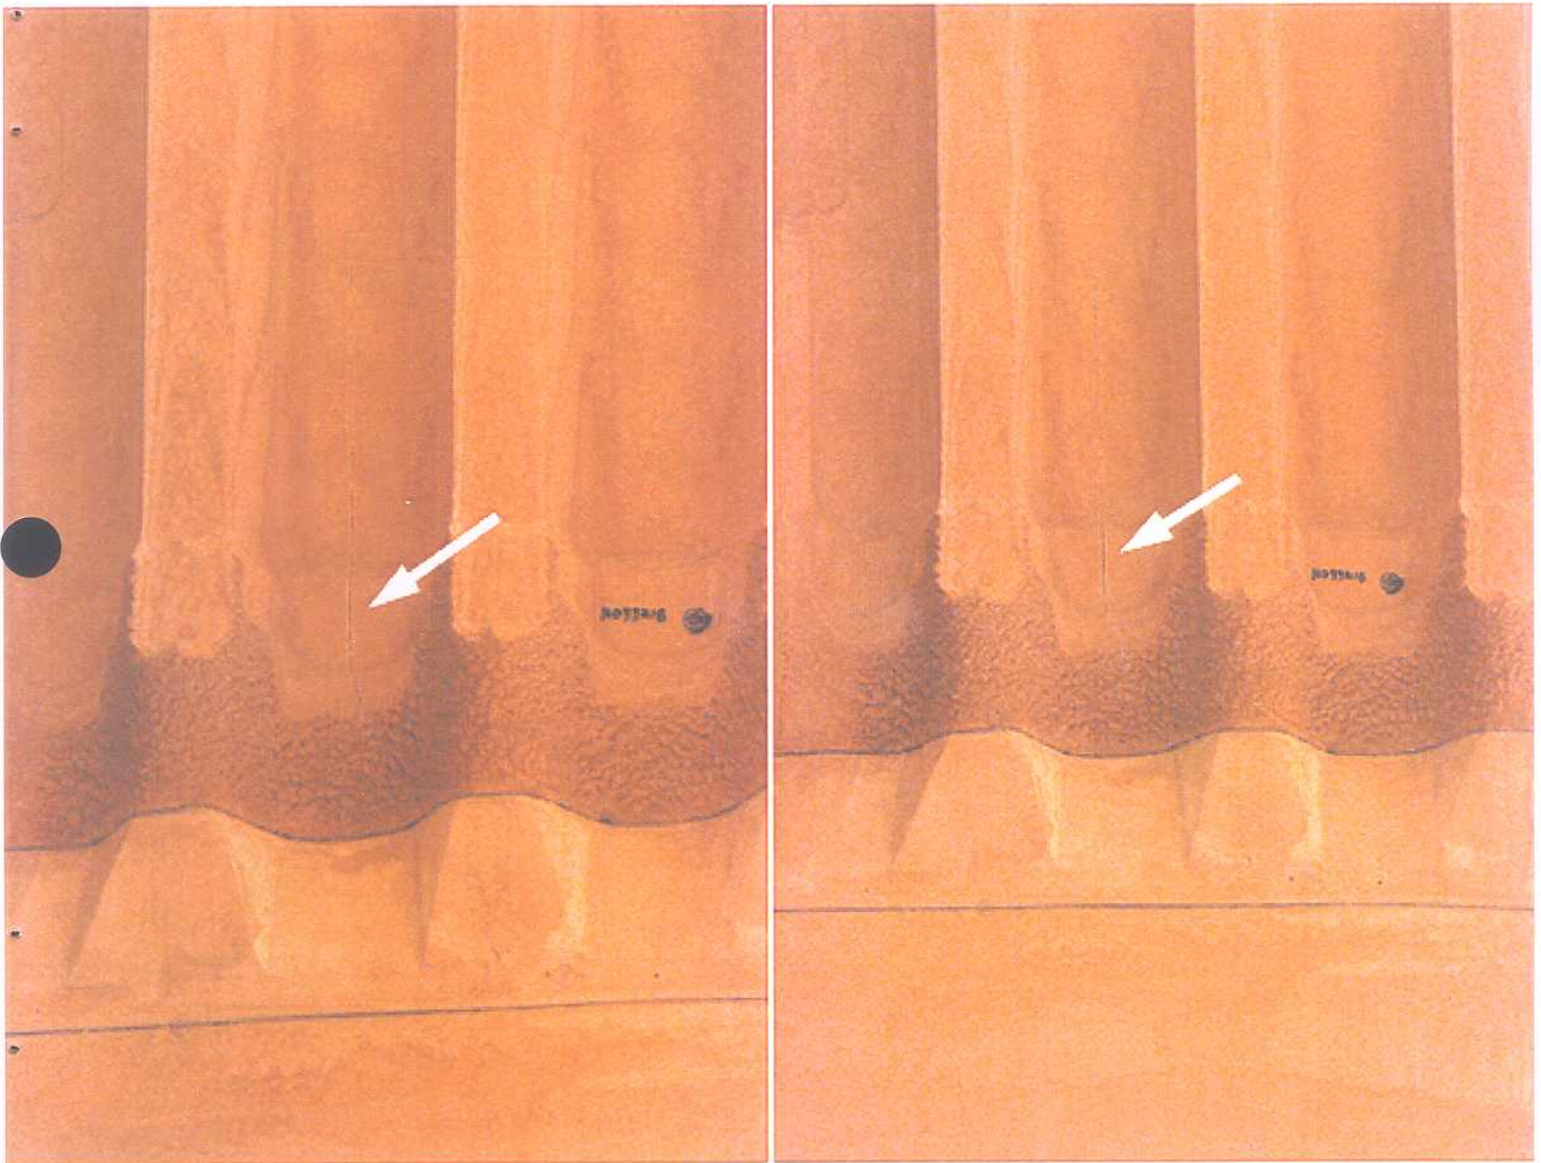
Photo 3: Hairline Cracks in Intertank Stringer Valleys

A total of six hairline cracks were detected in ET intertank valley TPS. There was one crack in each quadrant with the exception of the +Y+Z quadrant, which had three cracks. The cracks ranged in length from 4 to 18 inches, were less than 1/8-inch wide, had no offset, and exhibited no ice or frost. Therefore, all were acceptable for flight per NSTS-08303.

The number of cracks detected in ET intertank valley TPS increased from 6 to 12. There were cracks in all four quadrants. The cracks ranged in length from 2 to 18 inches, were less than 3/16-inch wide, had no offset, and exhibited no ice or frost. Therefore, all were acceptable for flight per NSTS-08303

The number of cracks detected in ET intertank valley TPS increased from 12 to 14. There were cracks in all four quadrants. The cracks ranged in length from 2 to 18 inches, were less than 3/16-inch wide, had no offset, and exhibited no ice or frost. Therefore, all were acceptable for flight per NSTS-08303

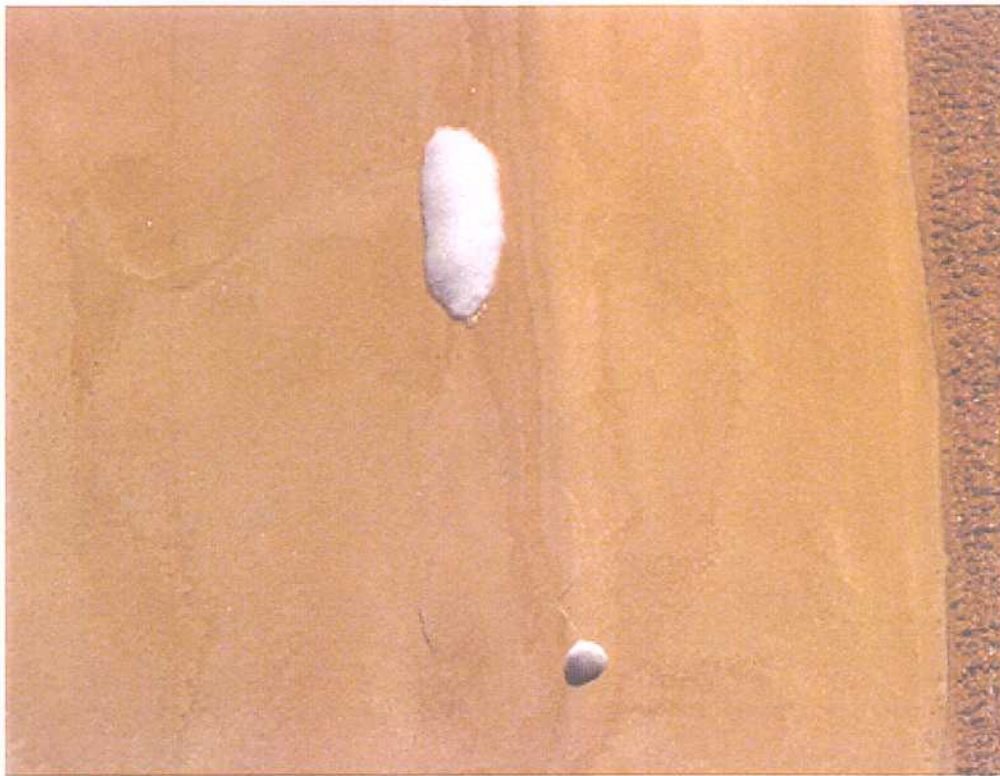
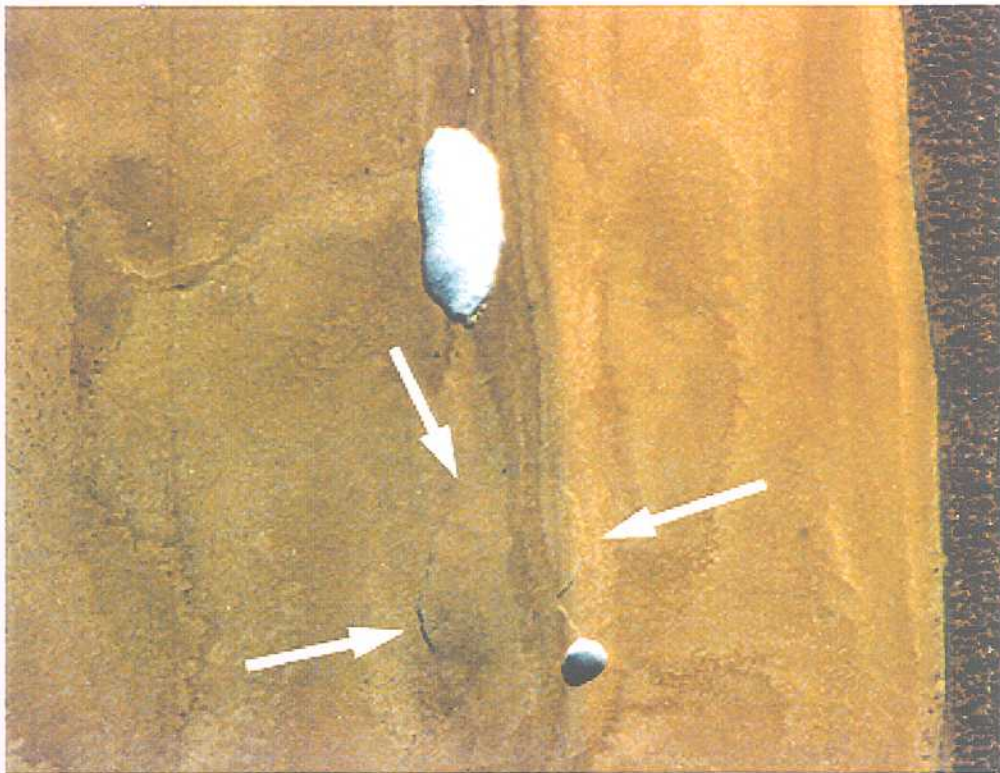
Photo 4: Crack in +Y Longeron TPS

IPR 101V-0310 was taken for two cracks in the +Y longeron closeout TPS since this condition was outside the NSTS-08303 guidelines. One crack was 4 inches in length by 3 inches wide by 1/8-inch wide in an inverted horseshoe shape. The second crack was horizontal, 2-inches long, and hairline in width. Although some frost was present, neither exhibited any offset nor unusual temperature gradients as imaged by the infrared radiometer. The two cracks were caused by thermal/mechanical induced stresses and localized defects in the thick BX-250 TPS closeout. In the case of the larger crack, a more severe condition occurred during the second cryoload of STS-99 (reference IPR 099V-0193). That condition was approved for flight via MRB on PR ET-92-TS-0010 and the same rationale, essentially, was used for the condition on this vehicle.

Normal and enhanced views of inverted horseshoe-shaped crack in the +Y longeron TPS

The crescent shaped crack at station XT-1960 previously documented on IPR 101V-0310 and MRB PR-ET-102-TS-0012 was carefully inspected. The crack was approximately 3-inches by 4-inches horseshoe shaped with an apparent 1/8-inch offset based on shadows cast on the adjacent foam. The ends of the crack were separated by approximately 4 inches of undamaged foam.

A second hairline crack on the +Y longeron closeout foam previously documented during the Final Inspection increased from 2 to 4 inches in length without offset. It remained a singular crack with no evidence of branching.
